Technical Report CERC-94-6  
March 1994

## Rehabilitation of the South Jetty, Ocean City, Maryland

by *Gregory P. Bass*  
*U.S. Army Engineer District, Baltimore*

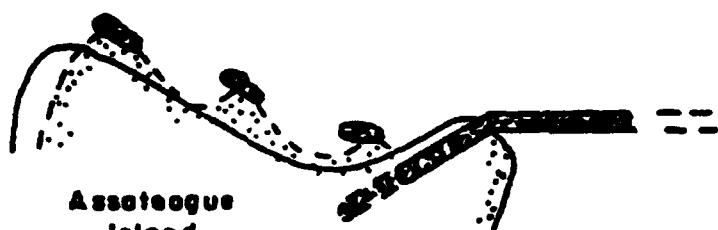
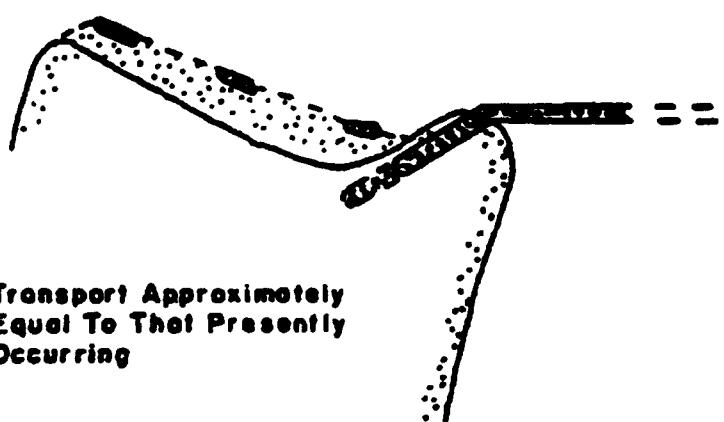
(a) Minimal Or No Longshore Transport

(b) Moderate Longshore Transport

(c) Transport Approximately Equal To That Presently Occurring

Figure 21. Evolution of the crenulate bays between the breakwater segments

In addition, the evolution of the crenulate bays between the breakwater segments is an indication of the performance of the jetty as a littoral barrier. As discussed by Dean and Perlin (1977), the evolution of the embayments is dependent on the supply of sand reaching them as illustrated in Figure 21. Analysis of the shoreline change map and the aerial photography indicates that the embayments between the breakwaters on Assateague Island are characteristic of the condition of minimal or no longshore sediment transport.

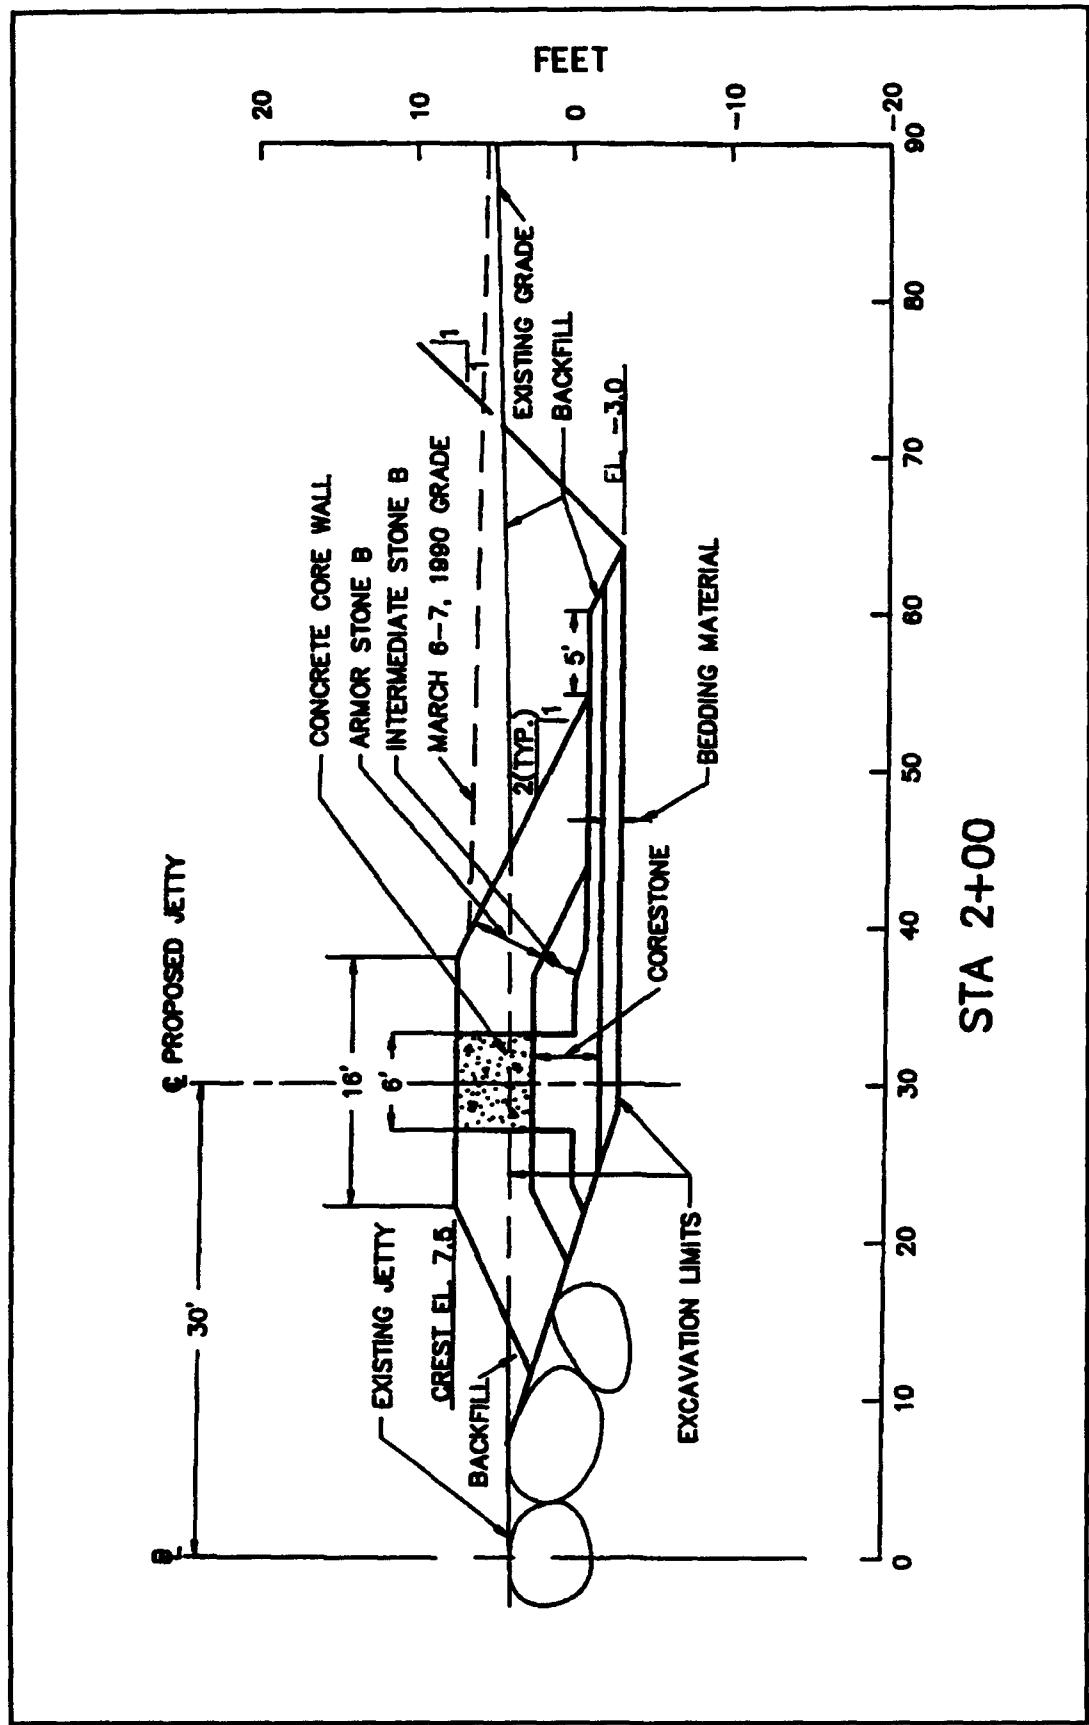
Figure 22. Sand accretion and the associated increase in elevation south of the jetty at sta 2+00

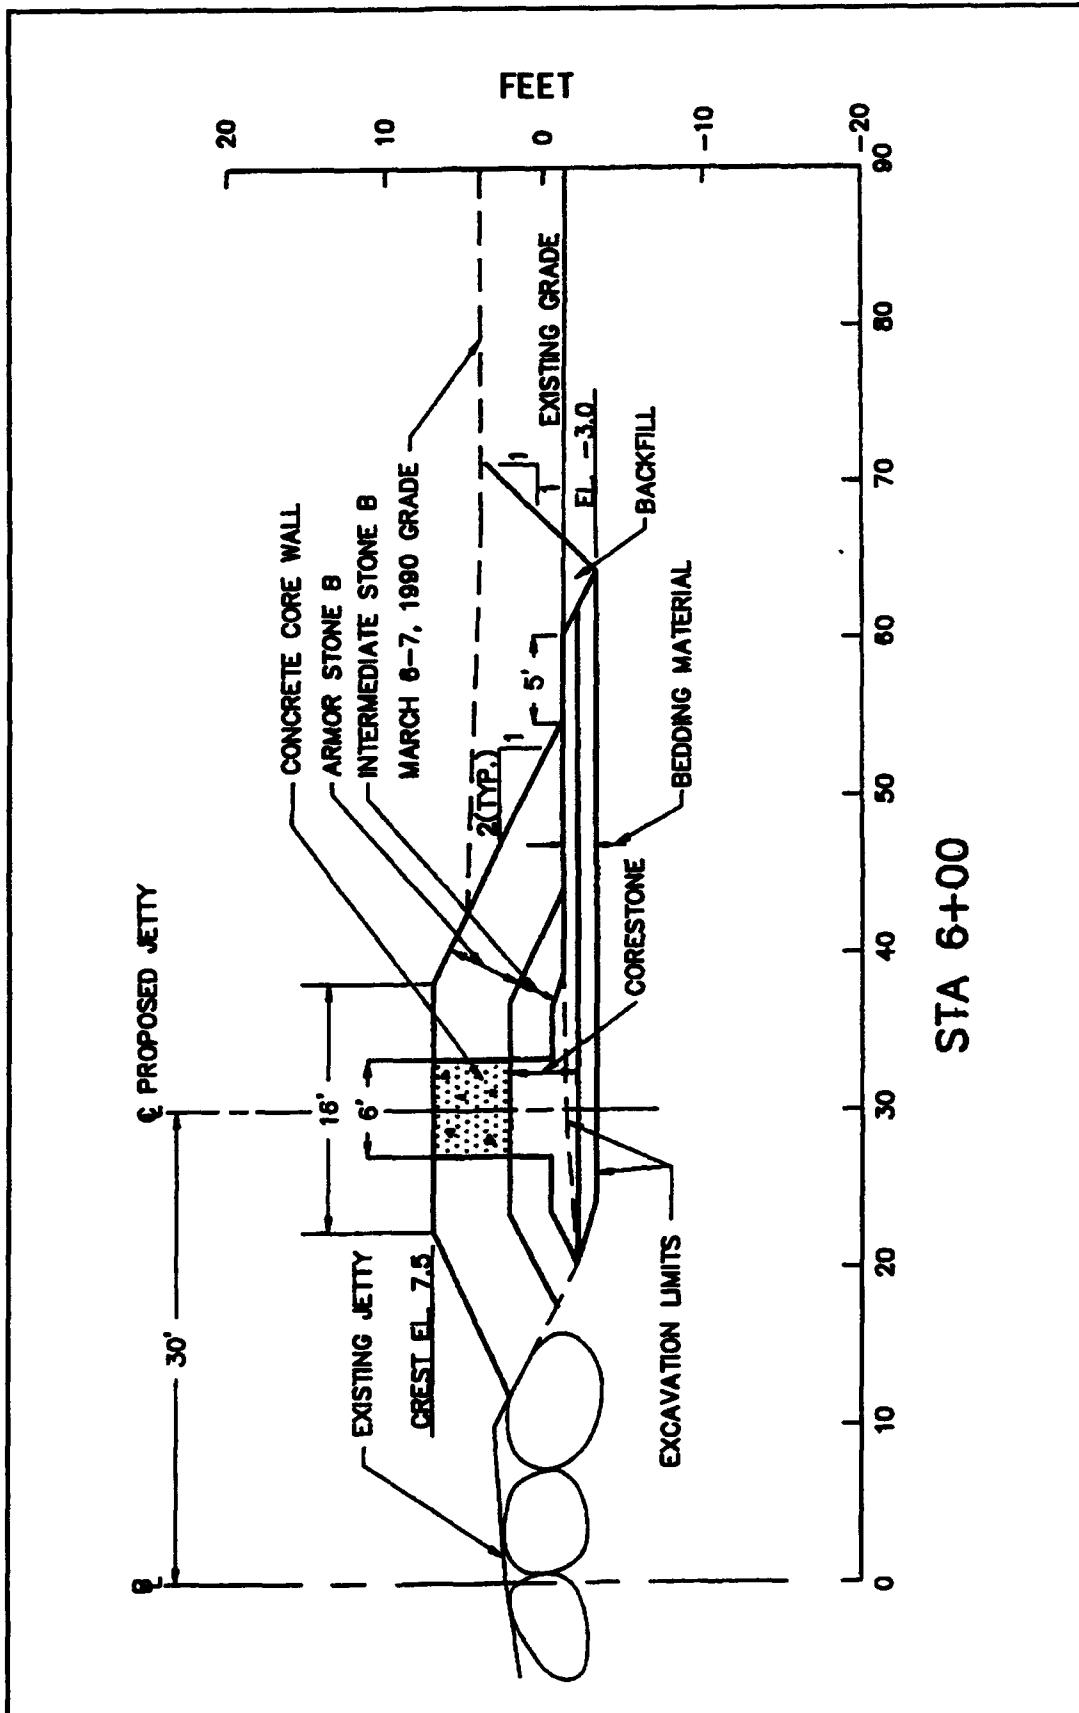
Figure 23. Cross-section of sand accretion and the associated increase in elevation immediately south of the jetty at sta 6+00

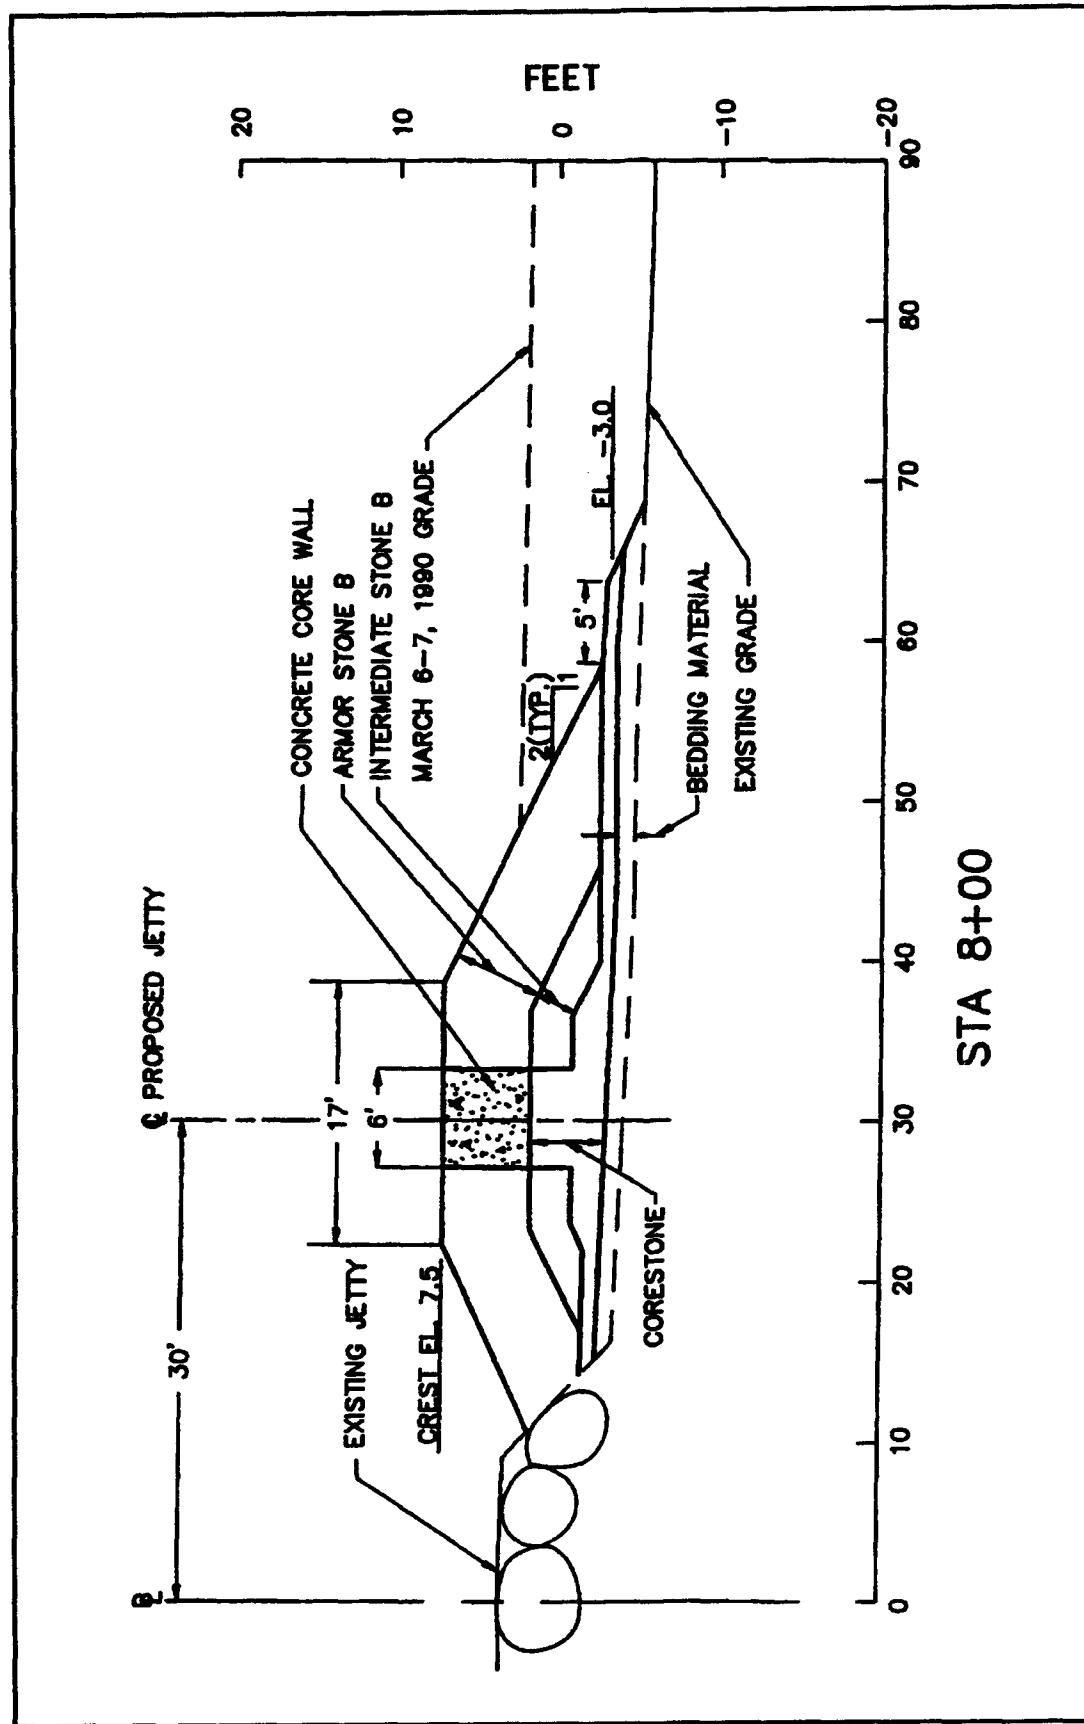
Figure 24. Cross-section of sand accretion and the associated increase in elevation immediately south of the jetty at sta 8+00

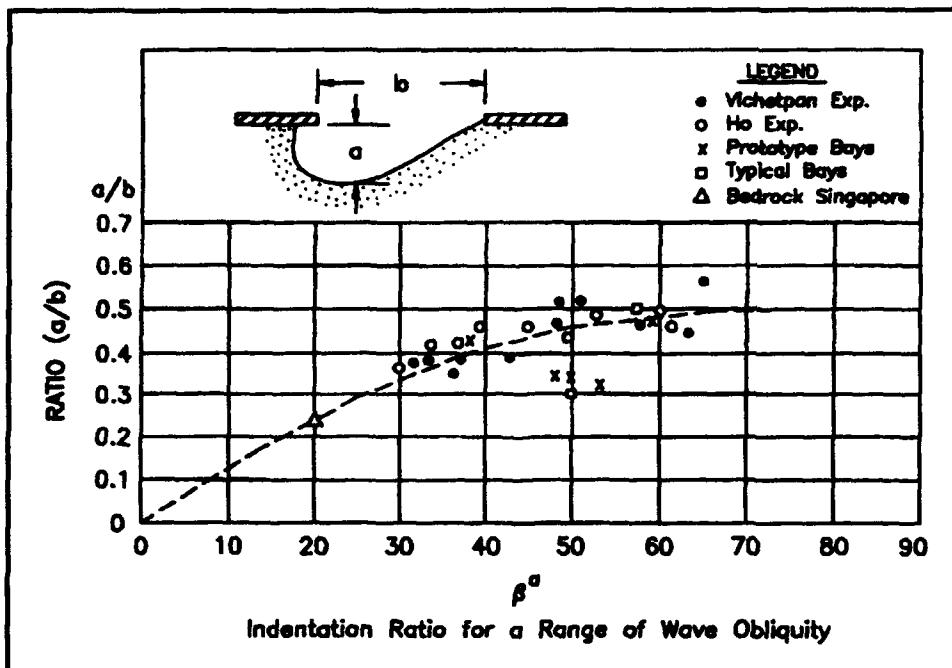
Figure 26. Results from physical model developed by Silvester and Ho (1972)

Based on physical model results, Figure 26, developed by Silvester and Ho (1972), indicates the relationship between the ratio of shoreline recession  $a$  and the spacing between headlands  $b$  versus various angles of wave obliquity for the equilibrium condition (i.e.,  $a_b = 0$  or no sand supply).

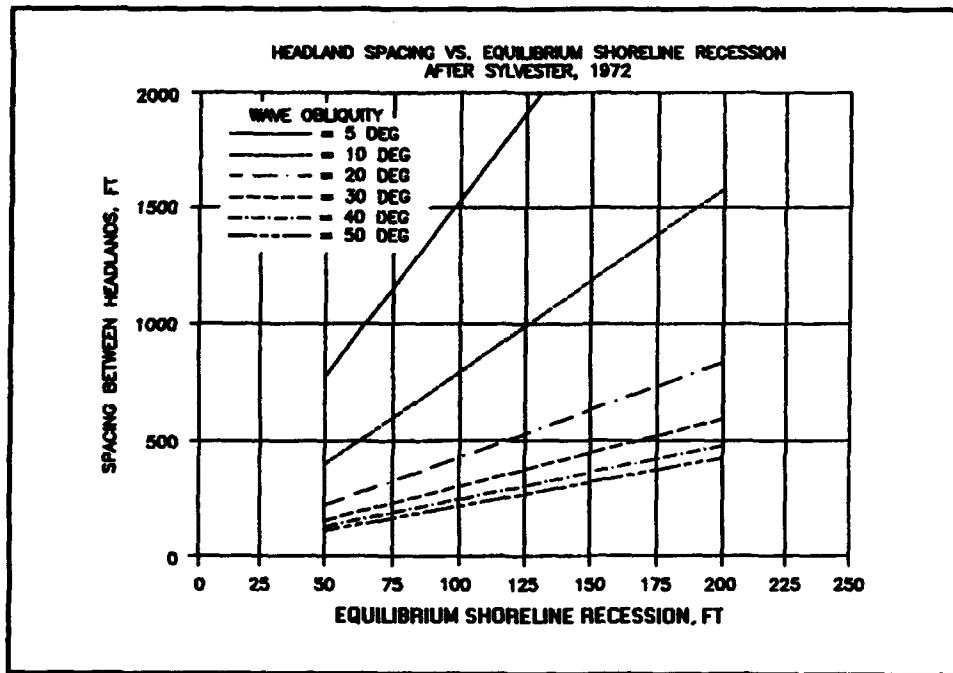
Figure 27. Relationship between  $a$  and  $b$  for various angles of wave obliquity

The predicted equilibrium shoreline resulting for this alternative is shown in Figure 27 along with the preconstruction mean high water shoreline. The mean high water shorelines from each of the aerial photographs

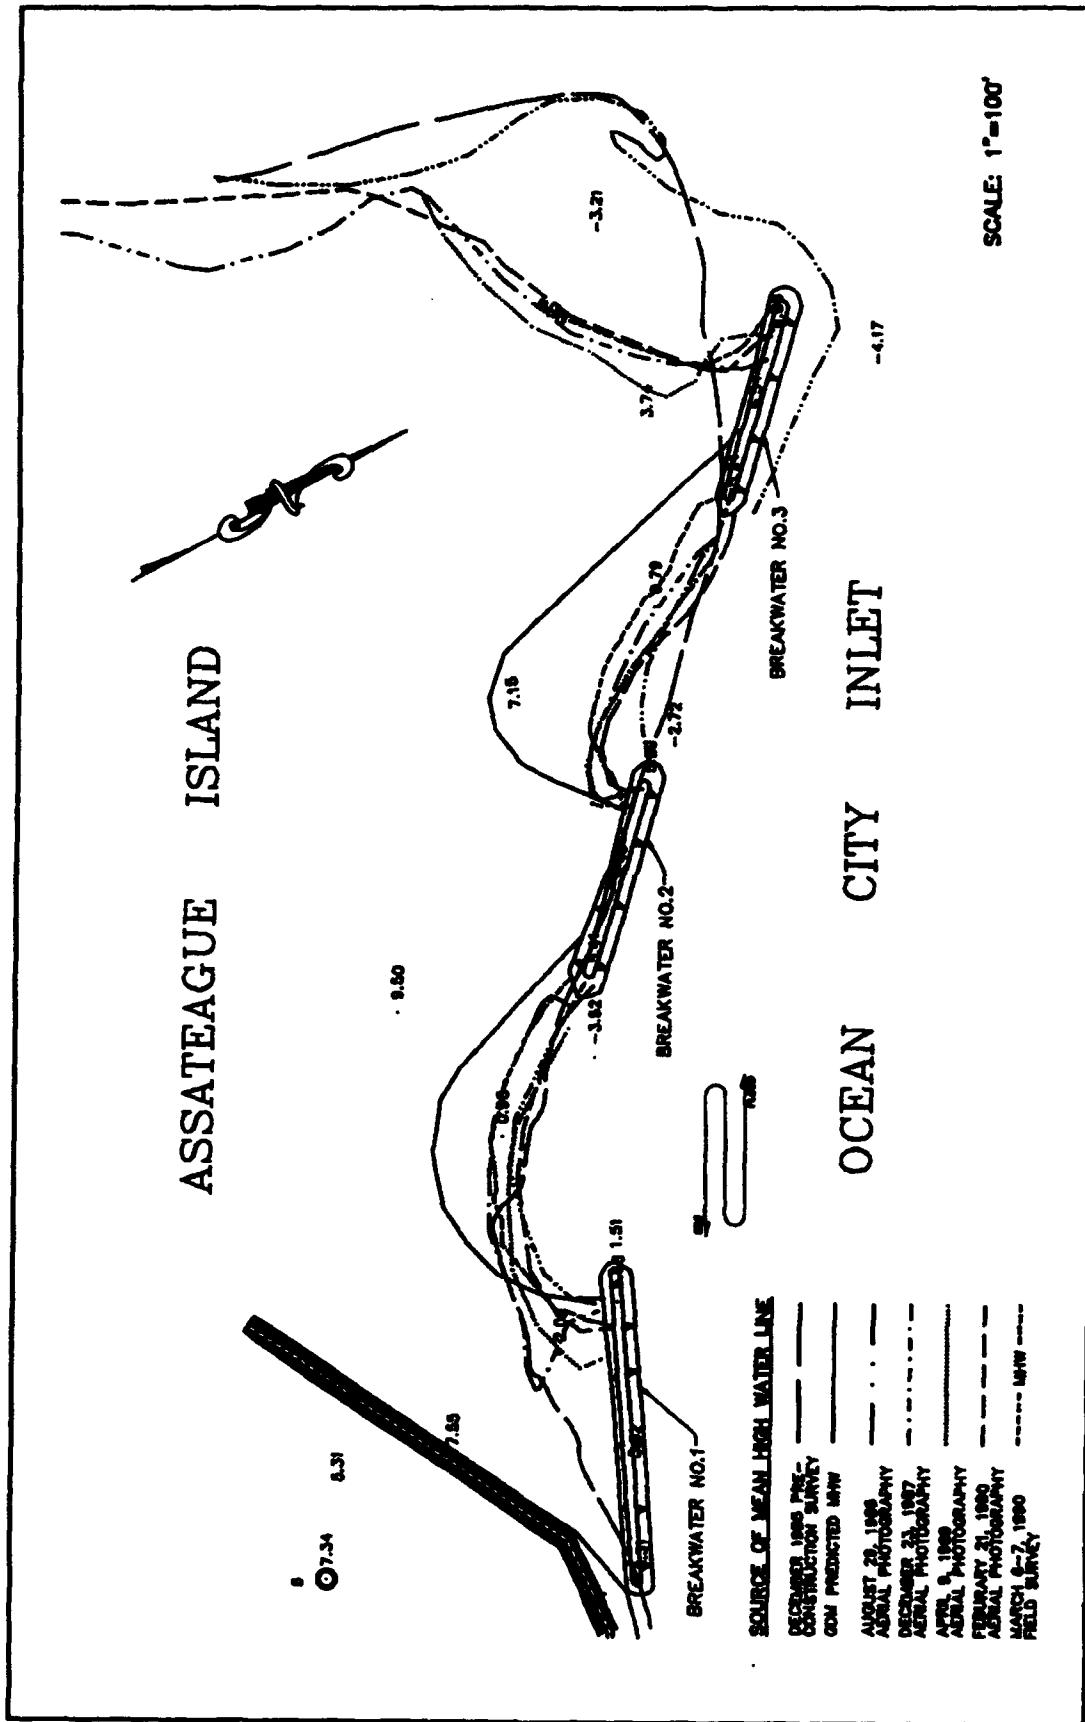
Figure 28. Migration of shoreline segments between breakwaters

are also shown in Figure 28. Analysis of Figure 28 indicates that following construction of the jetty and the headland breakwaters, the shoreline segments between the breakwaters began to evolve towards the predicted shoreline planform. For the shoreline segment between Breakwaters No. 1 and No. 2, the most significant movement occurred by December 1987 followed by some wobbling of the planform back and forth until reaching the position shown in the March 1990 survey. The shoreline segment between Breakwaters No. 2 and No. 3 shows a progressive evolution towards the predicted shoreline.

The equilibrium in either of the embayments would be expected to be a "dynamic equilibrium" subject to some fluctuation due to variations in the wave conditions and sediment transport reaching the locations. Overall, the headland breakwaters appear to be effectively stabilizing the northern shoreline of Assateague Island as evident from the shoreline position map (Figure 28).

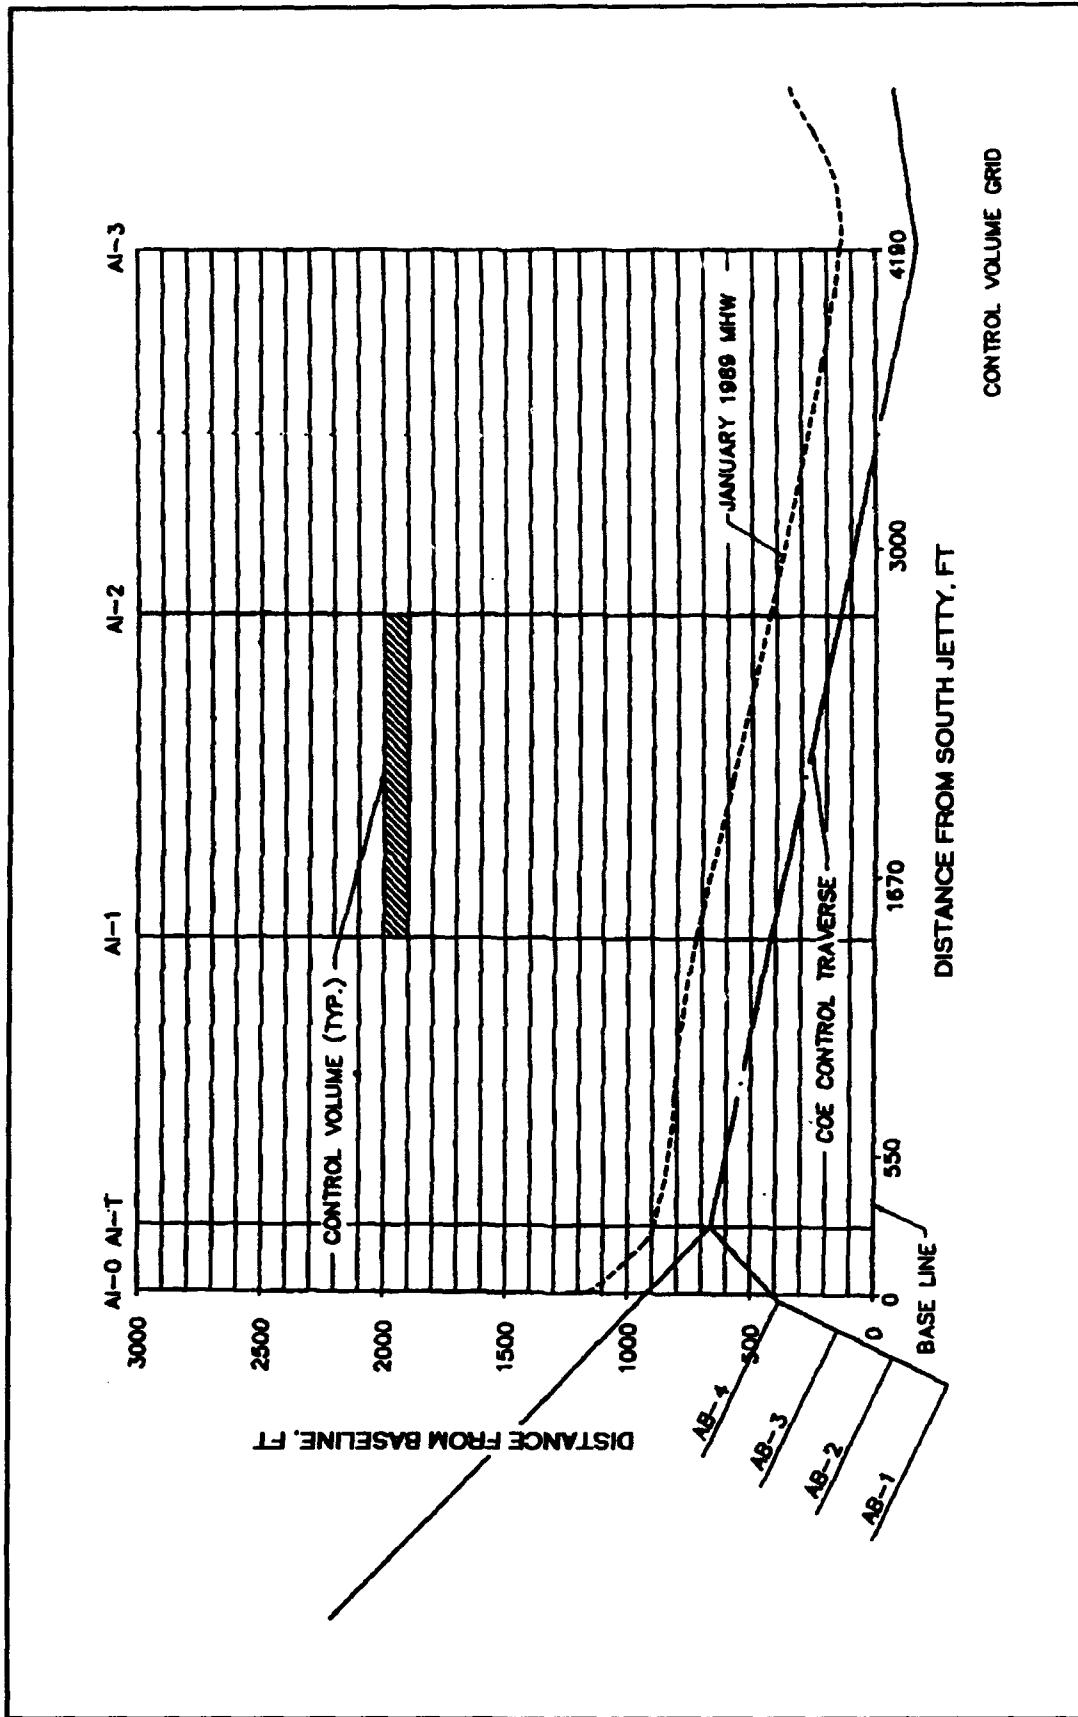
Figure 29. Grid pattern developed for analysis of the profile data for the south jetty

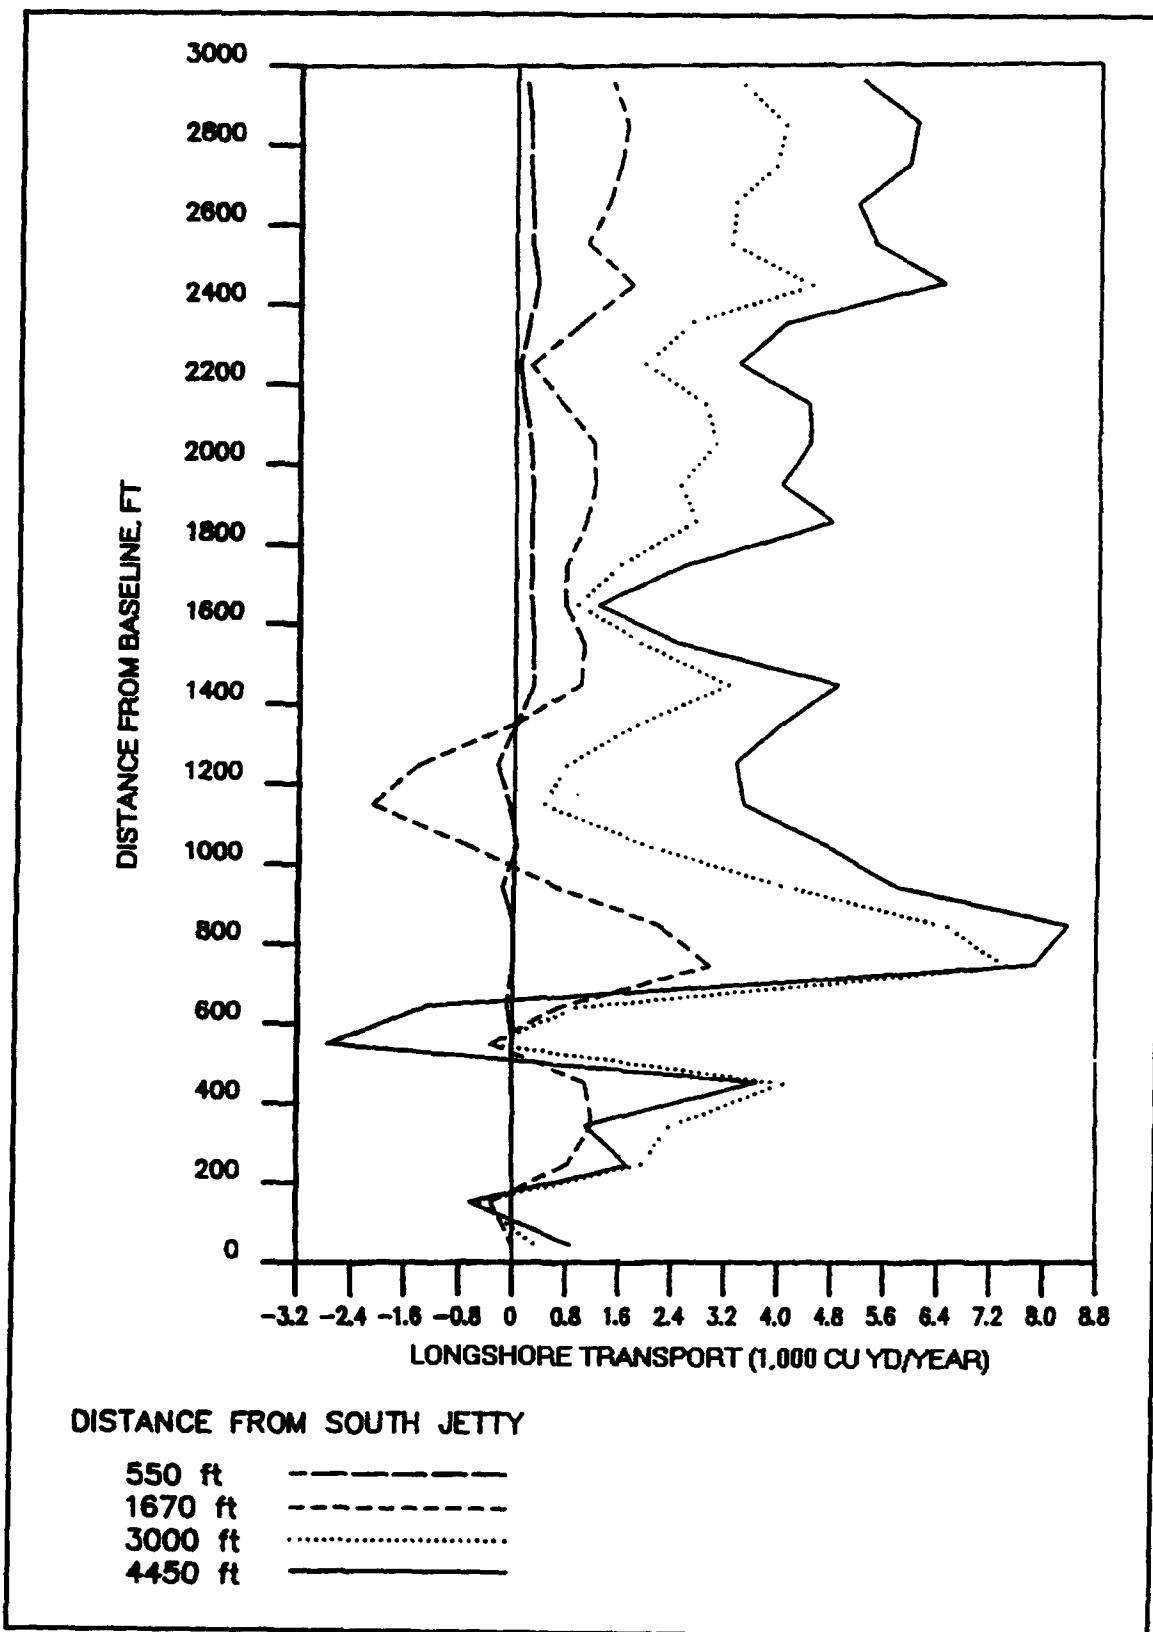
Figure 30. Incremental cell volumes indicating net longshore transport

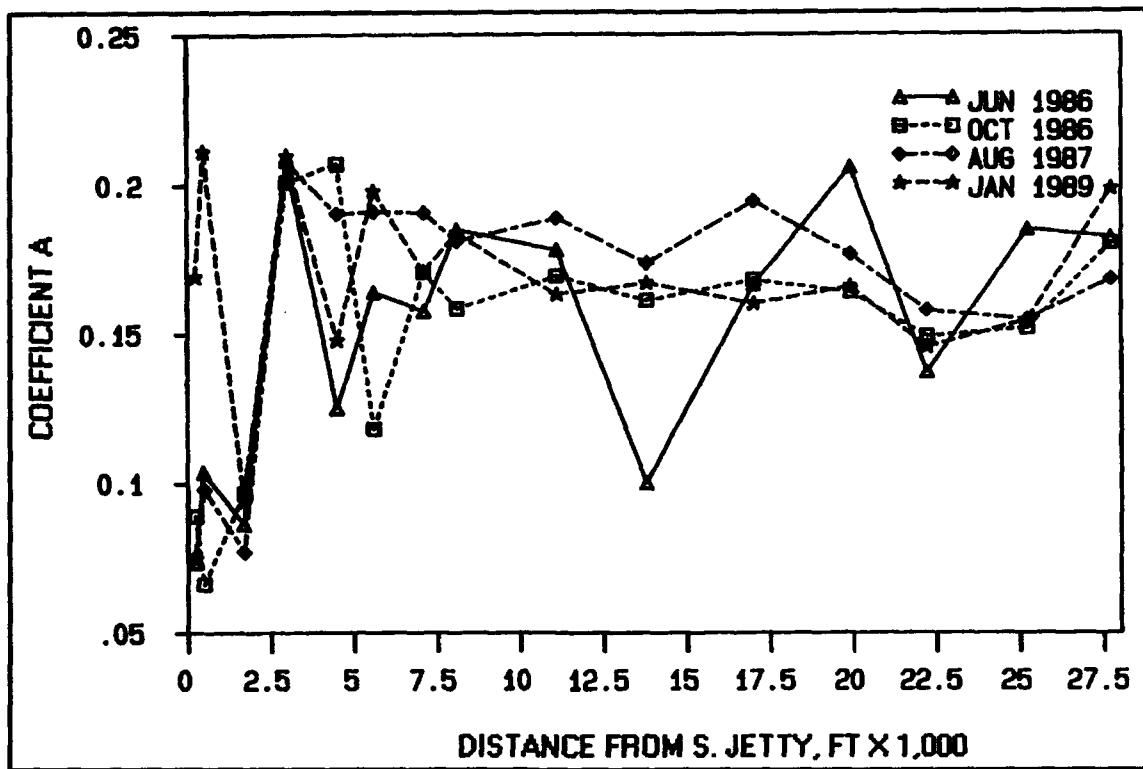
Figure 31. Variation in beach profile coefficient A along the coast of northern Assateague Island: depth 0 to -15 ft NGVD

A regression analysis of the data collected at various times throughout the monitoring effort determined the best-fit A value that satisfied the exponential equation given above. Figures 31 and 32 present plots of the variation in A along the shoreline as determined by the survey data collected. Figure 31 shows a plot of A along the Assateague Island shoreline as determined by a fit to beach profile data between elevation 0.0 and -15.0 ft NGVD. This range of elevations would be subject to short-term changes in beach profile shape. Figure 32 presents A values found by only fitting the exponential curve between elevation 0.0 and -25.0 ft NGVD. This figure is considered representative of the range of depths over which sediment moves including sediment movement during extreme storm conditions. In Figure 32, the best-fit of A between 0.0 and -15.0 ft NGVD of each profile shows larger variability than in Figure 31. This could be attributed to the shallower water depths responding on a more short-term basis to changing weather conditions. However, all the profiles seem to exhibit a fluctuating A value which is probably due to the changes associated with the onshore/offshore transport of the beach material. The effects of the ebb shoal and the south jetty are pronounced on the profiles, as shown by Figures 31 and 32. It should be noted, however, that the computed A values for the first two profiles of the January 1989 survey are biased on the high side due to the fact that this data set did not extend as far seaward as the other surveys. If it had, it is anticipated that these profiles would exhibit an A value more closely resembling the other data sets.

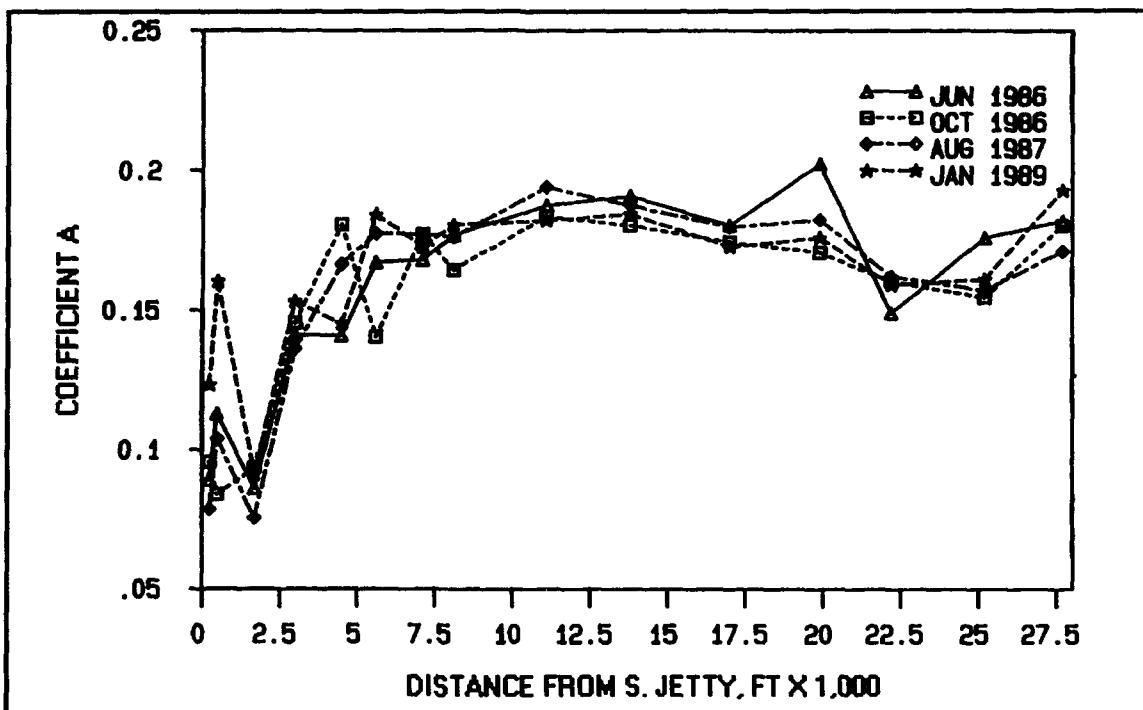
Figure 32. Variation in beach profile coefficient A along the coast of northern Assateague Island: depth 0 to -25 ft NGVD

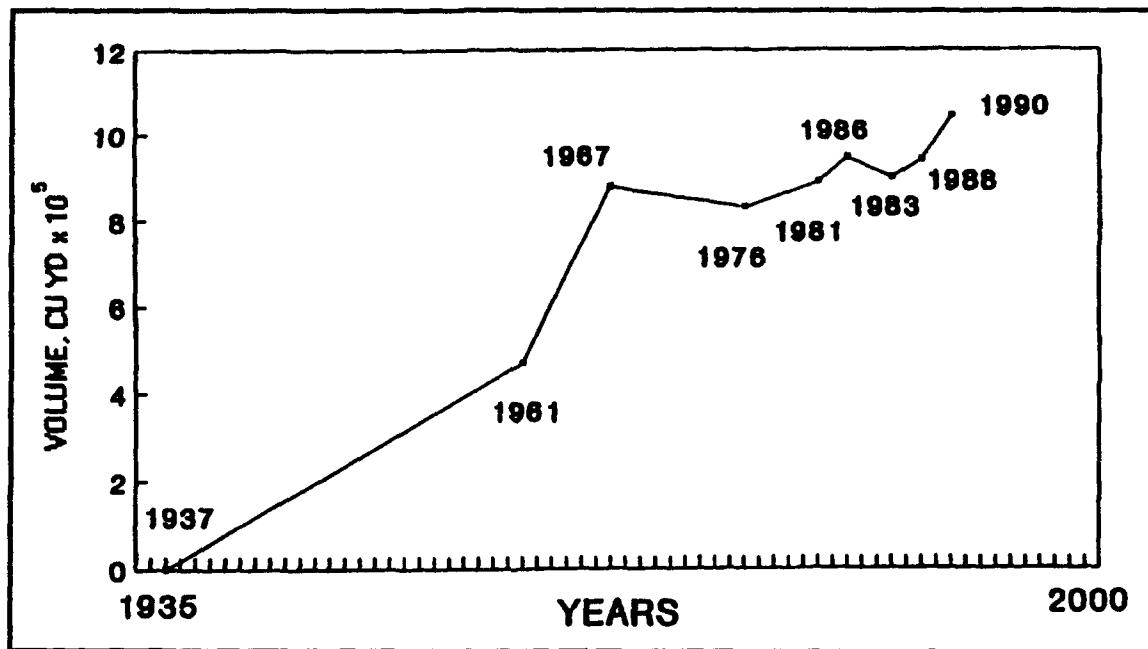
Figure 33. Cumulative volume for the ebb-tidal delta from 1937 through 1990

Cumulative volumes for the ebb-tidal delta (1937 through 1990) are depicted in Figure 33. Ebb shoal volume exhibited a net increase until the early 1960's, then rapidly rose until the late 1960's or early to mid 1970's.

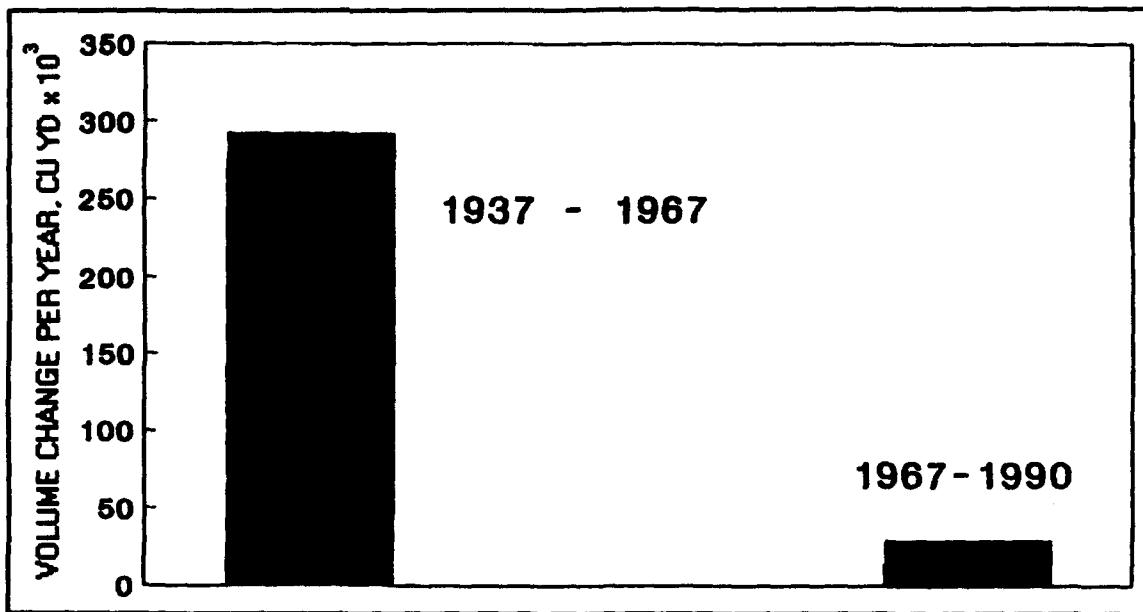
Figure 34. Ebb delta growth rate per year, 1937 to 1967 vs. 1967 to 1990

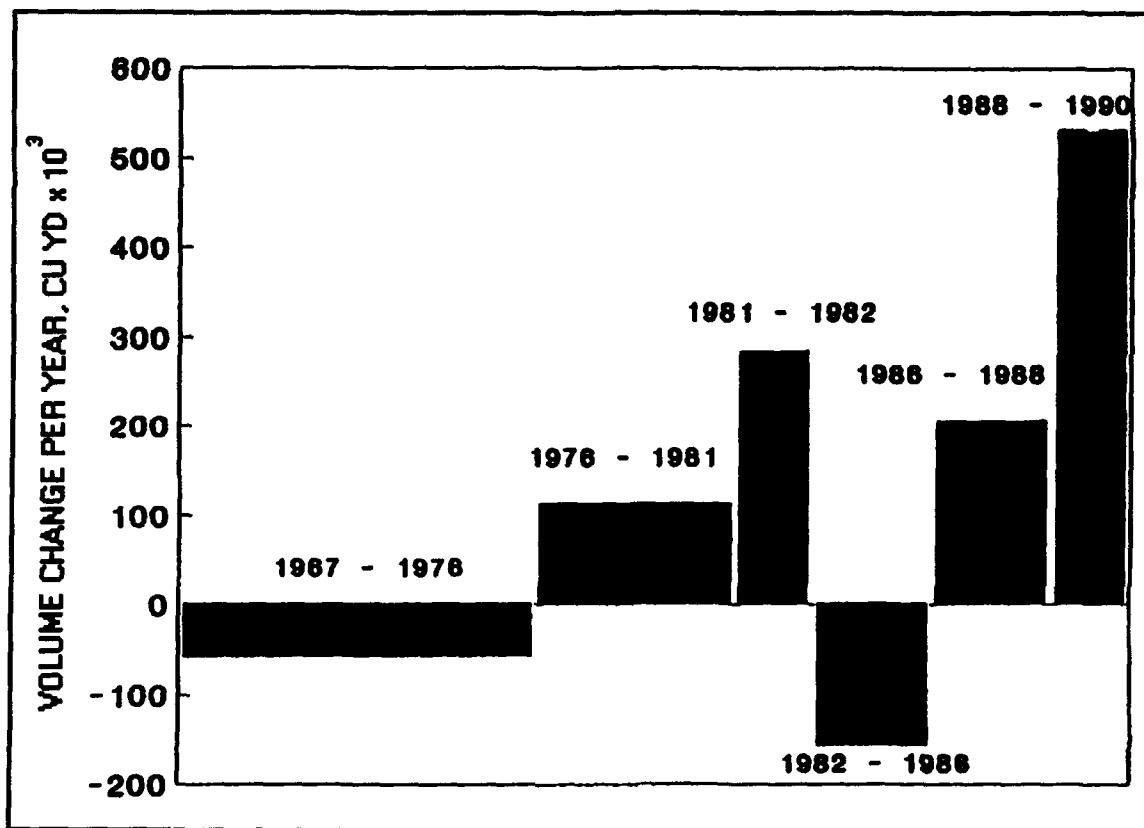
Figure 35. Ebb delta growth rate since 1967

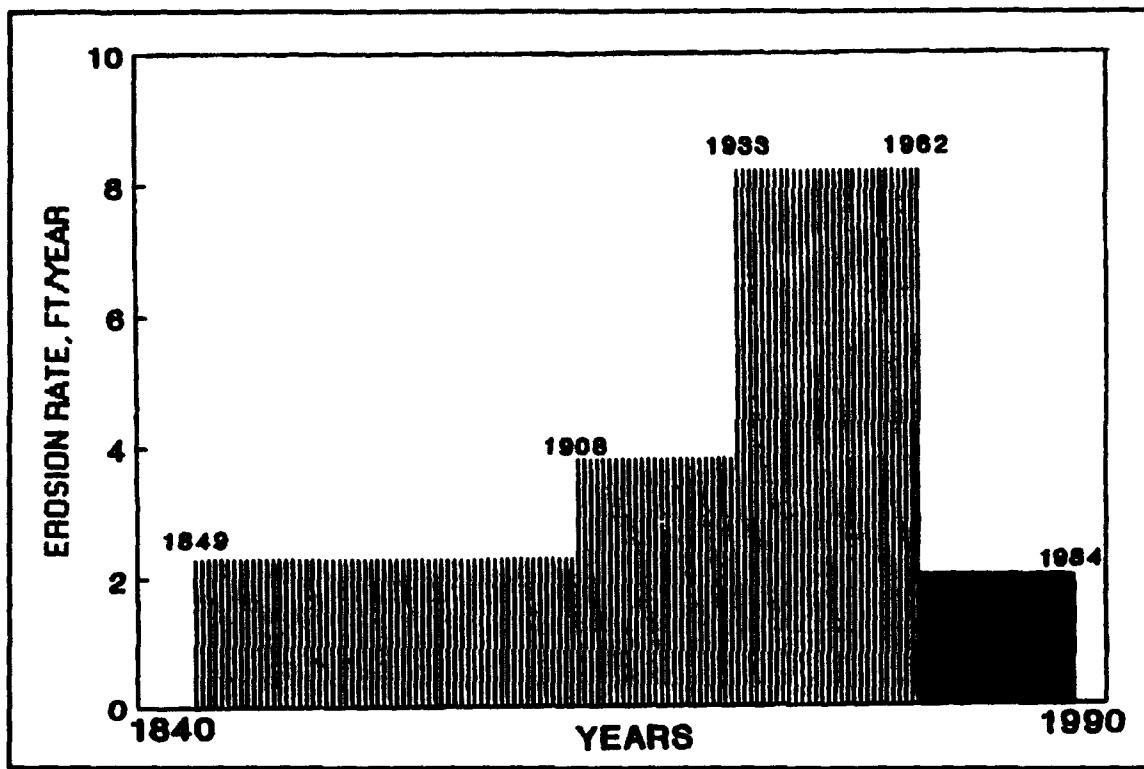
**Figure 36.** Historical shoreline erosion rate for northern Assateague Island. The light lined area represents data based on maps and air photos (Knowles 1985). The dark area is based on field profile surveys

Knowles (1985) determined Assateague Island's northern shoreline change rates between 1849 and 1984 using historical maps and profile survey data (Figure 36). The study area extended from the inlet southward for approximately 26,200 ft. From the early 1930's to the mid 1960's, the average rate of shoreline erosion reached a maximum of 26.9 ft/year. This accelerated erosion rate corresponded with the stabilization of Ocean City's inlet in 1935. Profile survey data between 1962 and 1984 show averaged erosional rates have decreased to 6.6 ft/year.

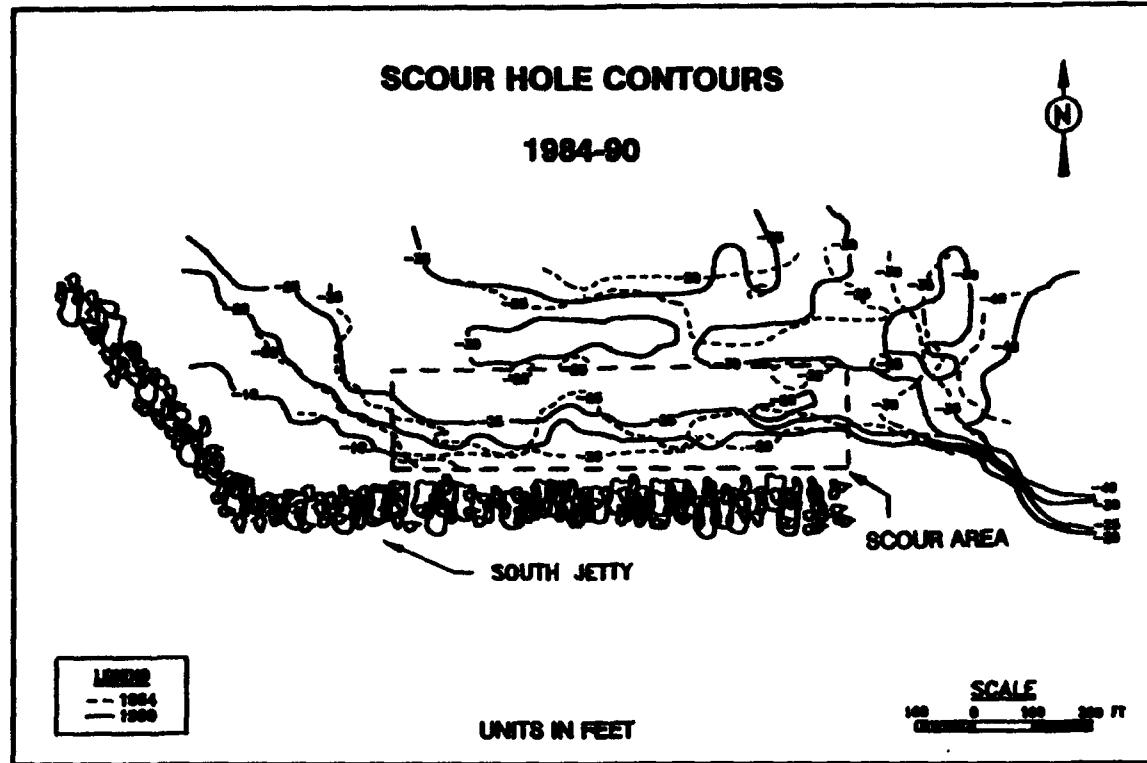
Figure 37. Scour hole contours indicating no erosion from 1984 to 1990

In January 1984, the Baltimore District requested that CERC conduct two side scan sonar (SSS) inspections of the South Jetty Major Rehabilitation Project. The integrity of the south jetty had been threatened by a tendency for the main tidal flow to channelize along the north side of the outer section, causing a deep scour hole. As part of the major rehabilitation, the Baltimore District required the construction contractor to hydraulically place sand fill into the scour hole with an 18-in. (later modified to 24 in.) stone blanket, and construct a stone berm at the base of the existing jetty. The stone blanket was specified as a 2,000-ft-long and 200-ft-wide rectangular zone. The purpose of the side scan sonar inspection was to document the sand-filling operation and uniformity of the stone cover. This work provided the Baltimore District with a method of quality assurance for documenting the critical stone blanket product. The first inspection was accomplished during the week of 30 August 1984. Another scour hole inspection was completed in June 1990, which allowed further evaluation of infilling of the scour hole since 1984. The results of these inspections indicated no subsequent erosion from 1984 (initial infilling) to 1990 (Figure 37).

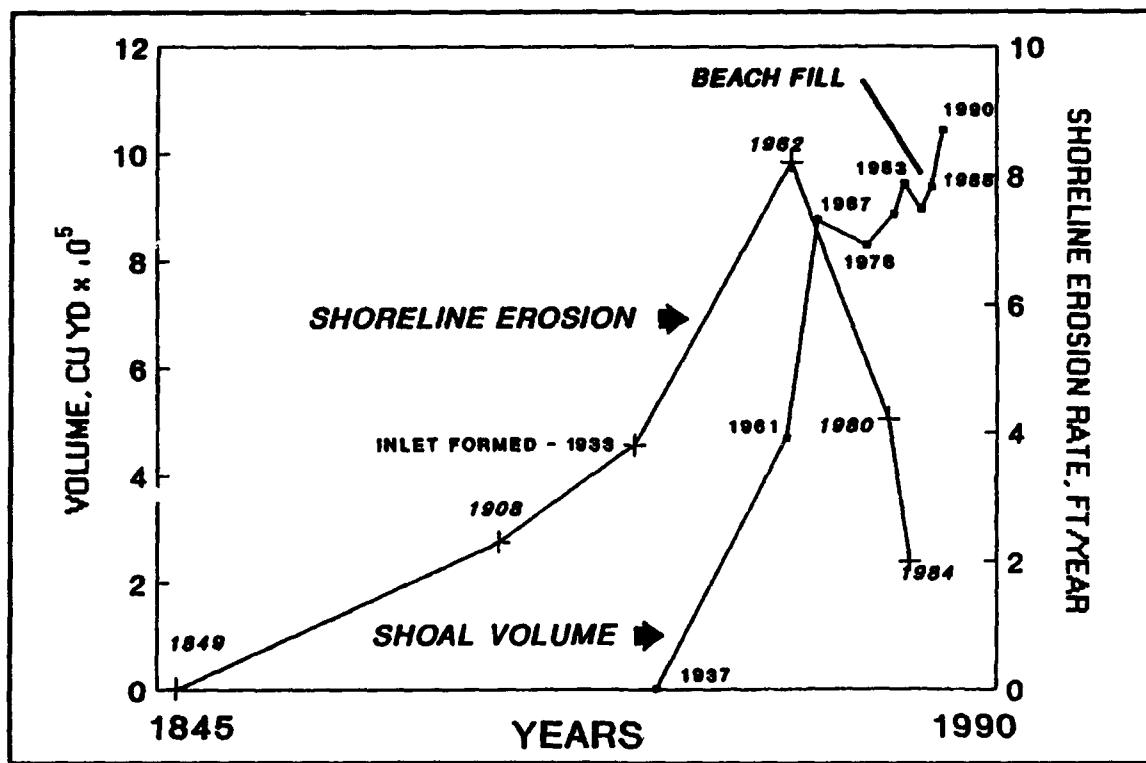
Figure 38. Cumulative shoal volume vs. change in Assateague Island's northern shoreline erosion rates

Results from this study of ebb shoal evolution suggest that natural bypassing of sand around Ocean City Inlet is an important process influencing shoreline change in the region. Further investigations are planned to fully document sediment bypassing at Ocean City Inlet. These include: (1) updating shoreline change measurements, (2) adding and updating bathymetry data, and (3) correlating process data (storms, waves, etc.) with measured shoal growth since 1967. This information should help improve shoreline erosion prediction estimates for northern Assateague Island. Preliminary examination of bathymetric shoal data, along with shoreline change data, support predictions of reduced erosion rates along Northern Assateague Island, suggesting that natural sediment bypassing is presently occurring.
